MOONEY INTERNATIONAL CORPORATION

SERVICE INSTRUCTION

> SERVICE INSTRUCTION SIM20-124 Date: April 12, 2018

SUBJECT: Prevent Inadvertent Rudder Trim Slipping During Extreme Deflections

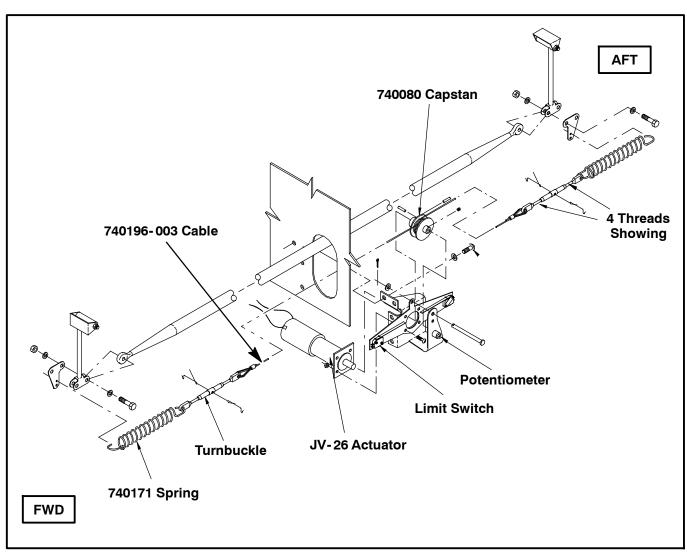
Figure SIM20-124-1 - Rudder Trim Rigging

INTRODUCTION: Mooney International Corporation has determined a solution to prevent inadvertent rudder

trim slipping during extreme deflections during take off. Use of a new cable and a special GSE

030035 tool during installation are advised to prevent a permanent set in springs.

- 1.5. Wrap 740196-003 cable around 740080-001 capstan so that the forward eye of the 740196-003 cable is 10.75 inches from the forward surface of the 740080-001 capstan. Temporarily secure the cable using several wraps of a suitable tape around the cable and capstan. Install actuator assembly into the aircraft. Refer to Figure SIM20-124-1.

- 1.6. Extend 740191 springs and secure with GSE 030035 spacer. Attach one end of the springs to 740198-001 brackets. Attach one eye of the turnbuckle to the spring and start two (2) to five (5) turns of turnbuckle's barrel to the eye. Use spacer GSE 030035 over spring coils. Perform step according to the applicable Mooney International Service and Maintenance Manual.

- **1.7.** Start turnbuckle's eye that is attached to the cable into the turnbuckle's barrel. Tighten turnbuckle until tension is applied to the springs.

- **1.8.** Remove spring extenders, tape, and rudder lock. The rudder should be neutral at 3 to 5 degrees left rudder deflection. Adjust turnbuckles to show 4 threads at each end of the barrel.
