MOONEY INTERNATIONAL CORPORATION SPECIAL LETTER

SPECIAL LETTER 18-08
Date: 8-29-2018

SUBJECT: To ADVISE MOONEY OWNERS/OPERATORS of the **GARMIN Service Bulletin No.: 1850 Rev. A, Dated: July 27, 2018 - Subject: Flight Stream 510 Software Upgrade to Version 2.41**

TO: All Garmin Aviation Service Centers
DATE: July 27, 2018
SUBJECT: Flight Stream 510 Software Upgrade to Version 2.41

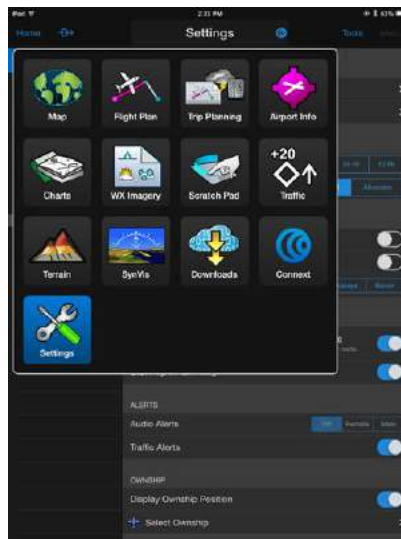
Figure 1. Garmin Pilot Home Screen

1. Connect to the Flight Stream device using Bluetooth.
2. Open the Garmin Pilot application.
3. From the Home screen, select the **SETTINGS** key.

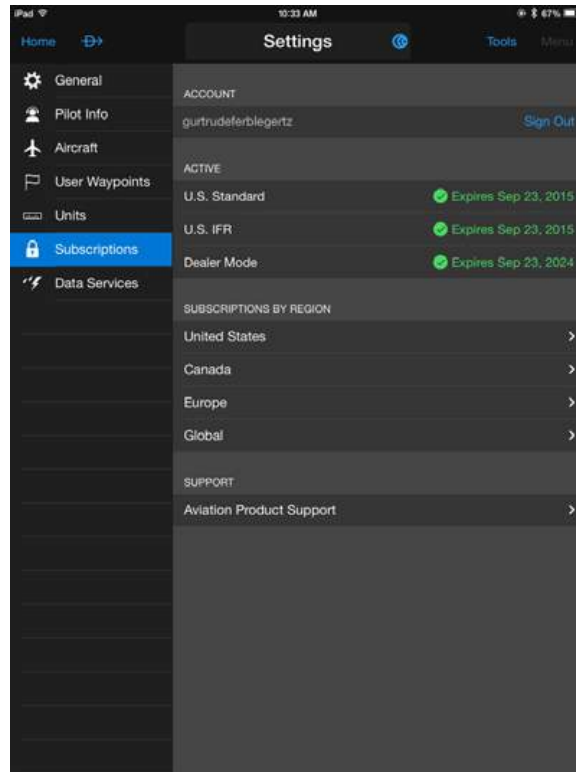
Figure 2. Garmin Pilot Settings Screen

4. Make sure **Dealer Mode** shows as an active subscription.

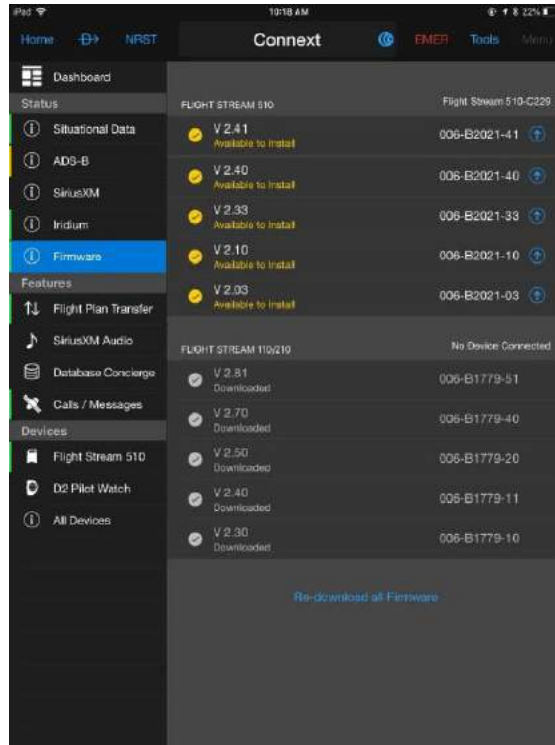
Figure 3. Garmin Pilot Connex Screen

5. Select the **HOME** key.
6. Select the **Connex** key.
7. Select the **Firmware** key.
8. Select Flight Stream 510 software version 2.41.

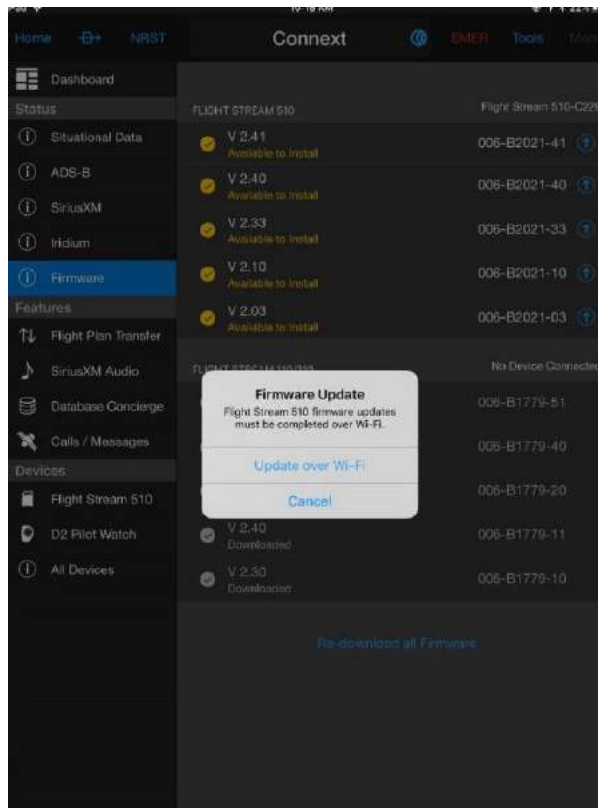
Figure 4. Firmware Update Wi-Fi Popup

- Flight Stream 510 software updates must be installed over Wi-Fi. Select **Update over Wi-Fi** to enable the Flight Stream 510 Wi-Fi network.

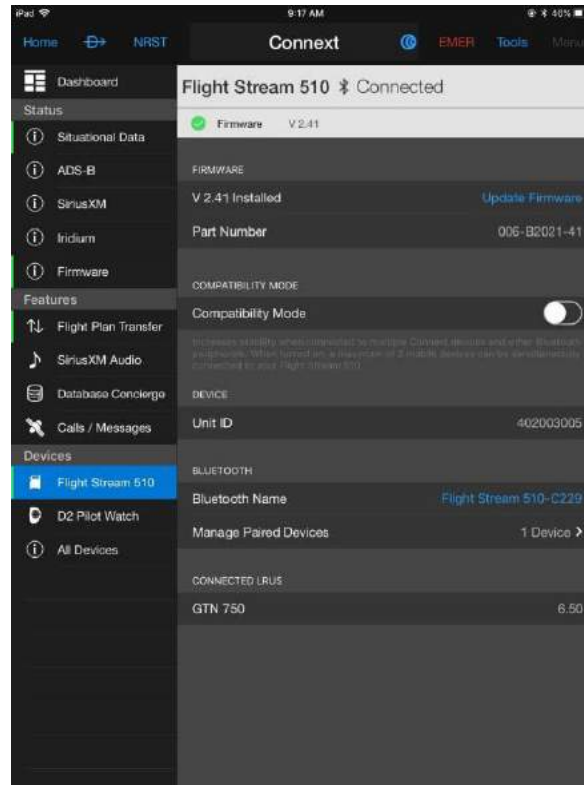
Figure 5. Updated Flight Stream

16. Make sure the firmware version now displays the updated software version.
