SERVICE INSTRUCTION SIM20-130 Date: SEPTEMBER 20, 2018

SUBJECT: MOONEY ULTRA INTERIOR DOOR HANDLE UPGRADE

MODELS/ SN
 M20U OVATION ULTRA 32-0002 thru 32-0005

AFFECTED:
 M20V ACCLAIM ULTRA 33-0002, 33-0003, 33-0005

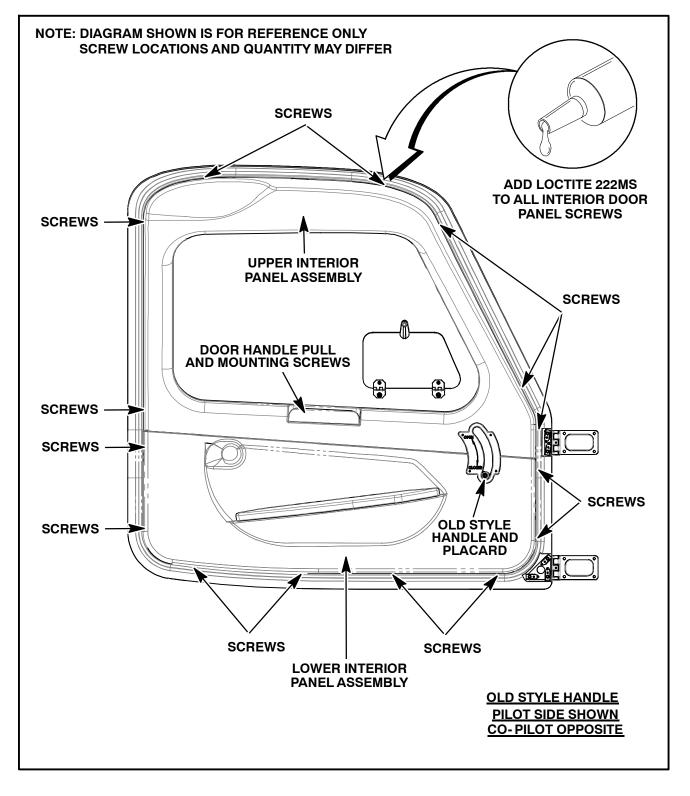
Figure SIM20-130-1 - EXISTING INTERIOR DOOR PANEL AND HANDLE ASSEMBLY

- 1.1. On Pilot and Co-Pilot side entrance doors, cover wing walk area with protective cover.
- **1.2.** Open Pilot and Co-Pilot doors, remove interior door handle placard screws, and remove placard as shown in Figure SIM20-130-1.

- **1.3.** Remove door handle pull screws and remove upper and lower interior door panel screws, keep for reassembly, remove panels from door as shown in Figure SIM20-130-1.

- **1.11.** Carefully cutout a hole thru panel for bellcrank arm to protrude, see figure SIM20-130-2.
- **1.12.** Install Upper and Lower interior door panels, use loctite 222MS on screws and secure panels as shown in Figure SIM20-130-1.

- 2.4. Once door panels are returned from Mooney, test fit door panels, and install 130400-65 Trim Ring with RAS13270 adhesive in center of hole cutout. Install Upper and Lower interior door panels, use loctite 222MS on screws and secure panels as shown in Figure SIM20-130-1.

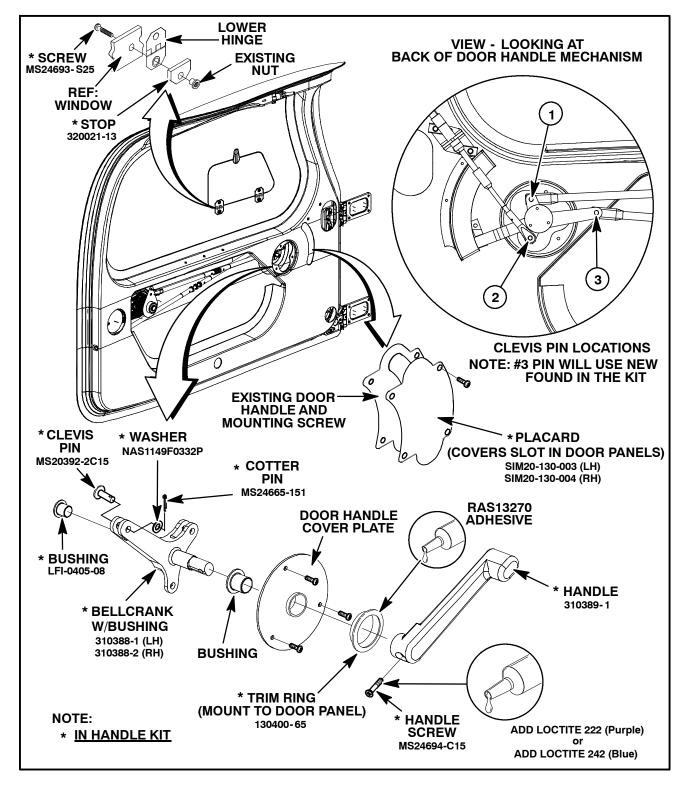
Figure SIM20-130-2 - INTERIOR DOOR HANDLE MECHANISM AND STORM WINDOW

- **1.6.** Install new bushing LFI-0405-08 into bellcrank and install into door. Due to tight clearance, it may be helpful to temporarily install clevis pin #3 into bellcrank hole and temporarily secure with a cotter pin before installing into position. Install #1 and #2 clevis pins, washers and new cotter pins. On # 3 clevis, carefully pull temporary cotter pin out, slide clevis pin out far enough to install clevis, push #3 clevis pin thru and add washer, secure with new cotter pin. See figure SIM20-130-2.

- **1.15.** Add Placard p/n 150110-A1048B (LH) or 150110-A1049B (RH) to upper door panel.
- 1.16. Add Storm Window Stops: (This limits travel of storm window in the open position)a. Remove lower hinge screws, see Figure SIM20-130-2.

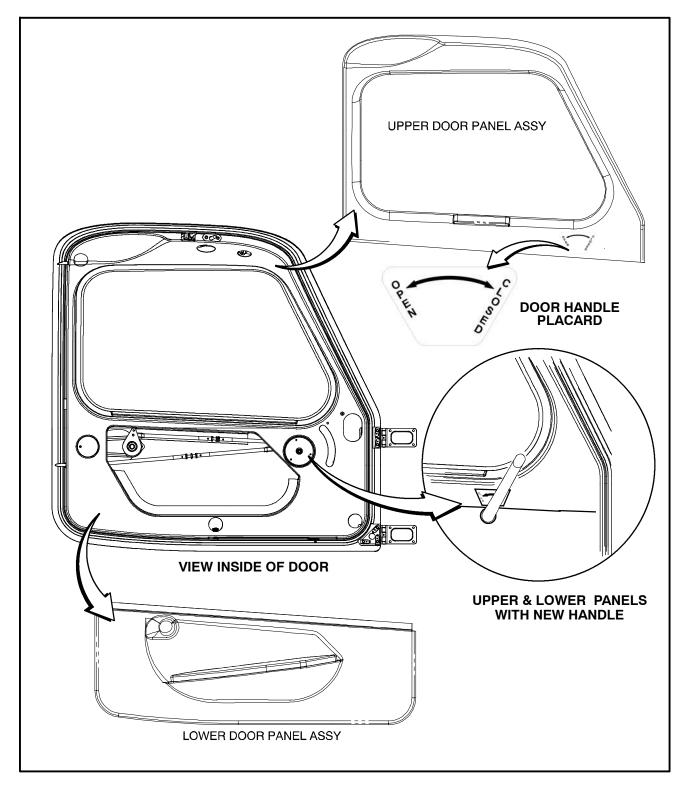
Figure SIM20-130-3 - NEW INTERIOR DOOR PANELS
